Deploying Drones for Spatial Modeling of Displaced Landmines in **Bosnia Herzegovina**

Heavy floods and landslides in Bosnia Herzegovina shifted minefields and explosive remnants of war (ERW) into inhabited areas. The Belgian Royal Military Academy (RMA) team worked with the Bosnia and Herzegovina Mine Action Centre (BHMIC) to use drone images that would help model the potential locations of some of the many displaced ERWs and mines. These models then were used to narrow down the search radius for demining teams.

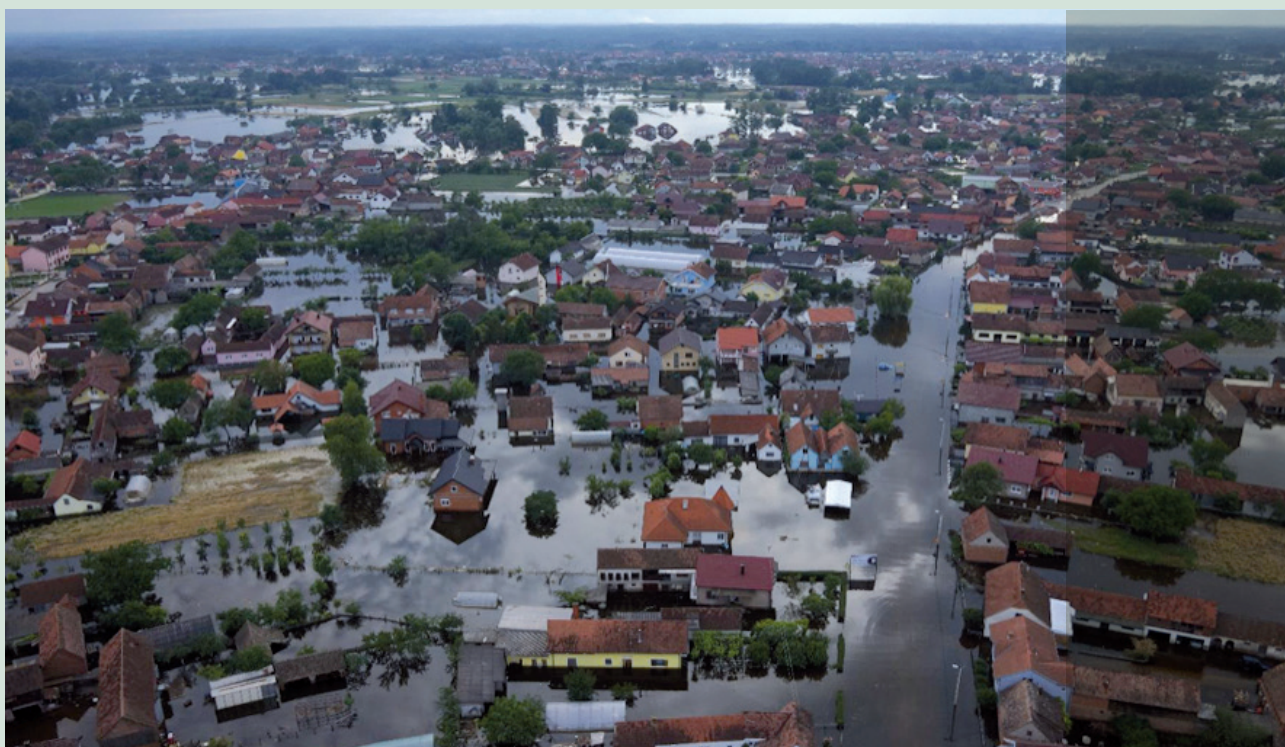
Figure 1 Aerial image of flooded areas captured by the ICARUS UAV. © ICARUS.

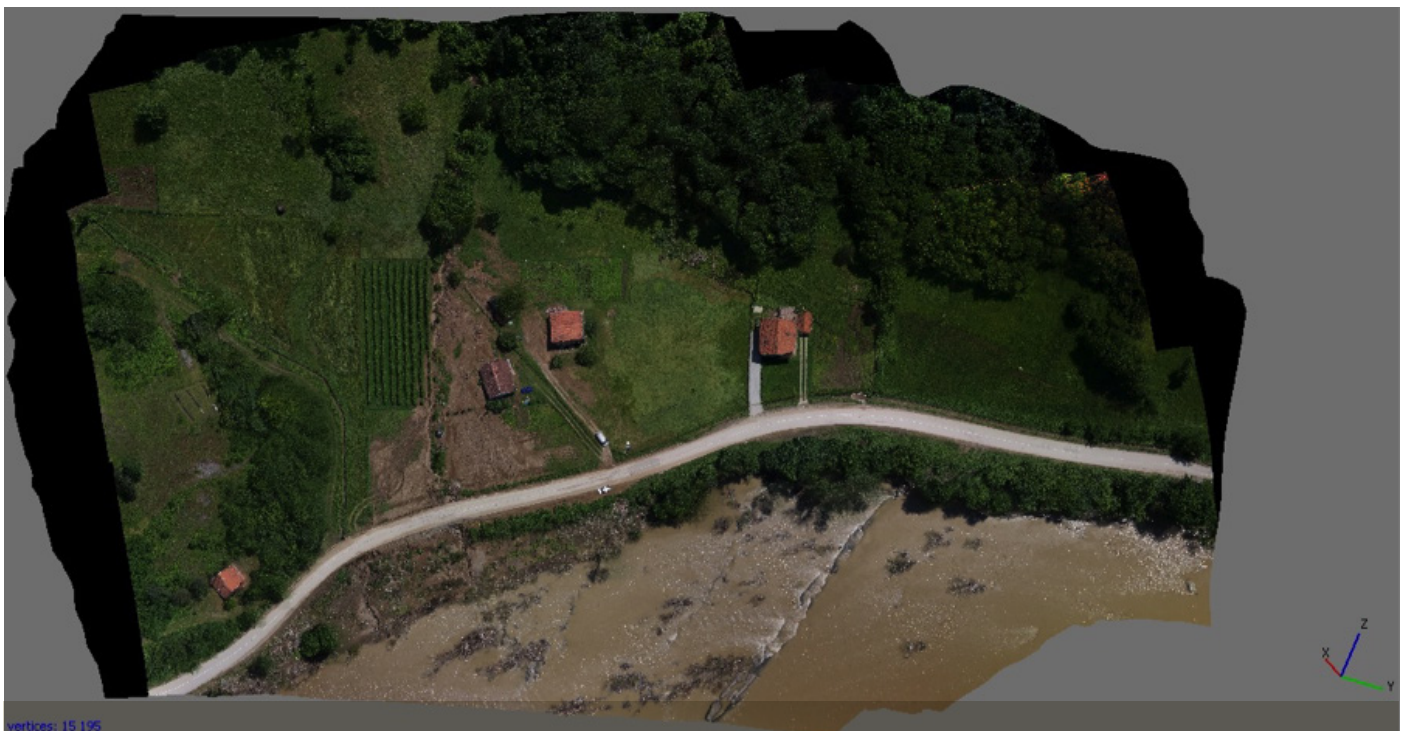
Figure 2 Example of a digital ortho-mosaic depicting a landslide that crosses a minefield in the upper part of the mosaic. The digital ortho-mosaic was derived from aerial images captured by UAVs.

models, which were accurate to within a few centimetres per pixel, enabled the RMA team to estimate the size of the landslide and to position it on cartographic and mine information system database layers. In fact, the RMA team was able to determine the maximum length of the landslide (142 metres), width (55 metres) and the total area covered (6 650 square metres). The mosaics, DSMs, DEMs and 3D models were then shared with the Department of Geodesy at the University of Sarajevo, where statistical models for assessing the impact of flooding on erosion enabled the team to determine whether ground erosion had potentially displaced any of the known mines. Taken together, these approaches allowed RMA and the University of Sarajevo to identify new areas where unexploded mines might now be located and therefore to declare them risk areas.

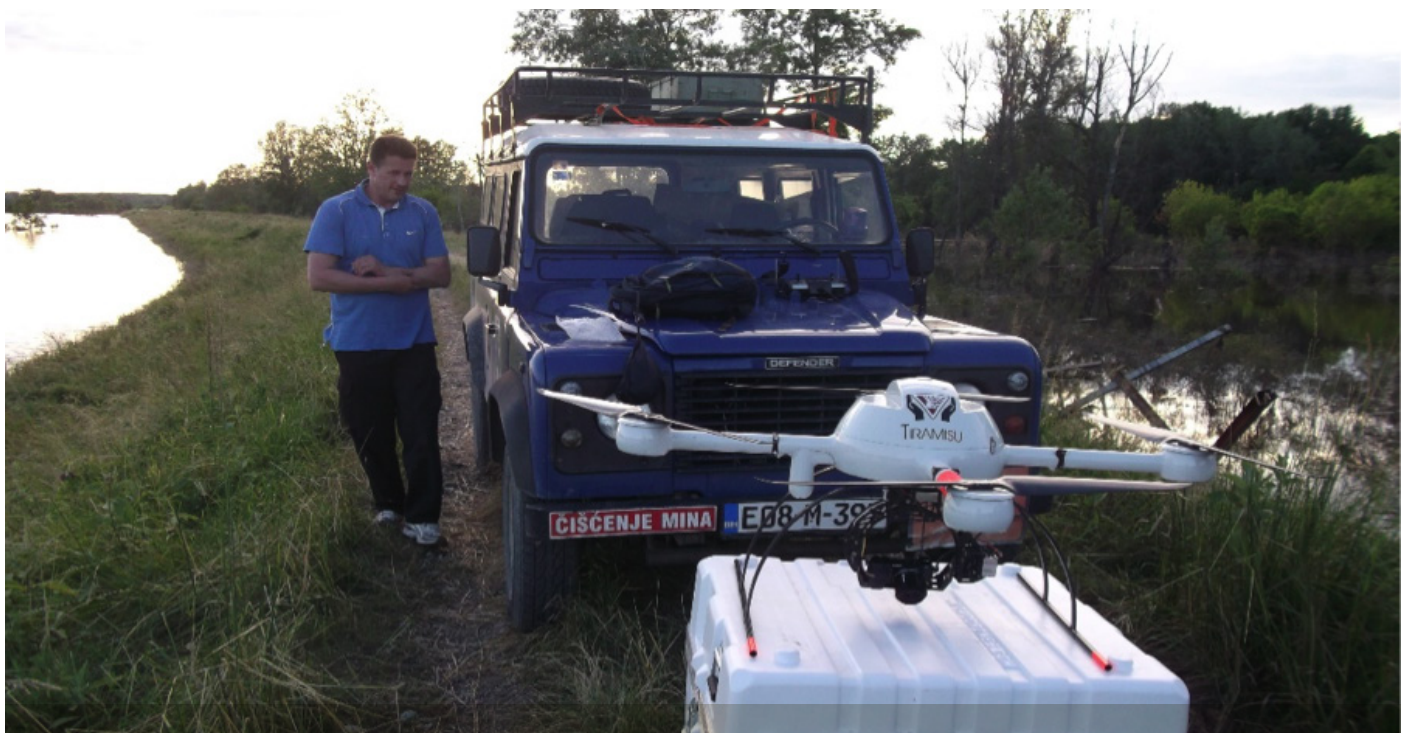
Figure 3 ICARUS and partners setting up their multi-rotor UAV to inspect flooding. © ICARUS.

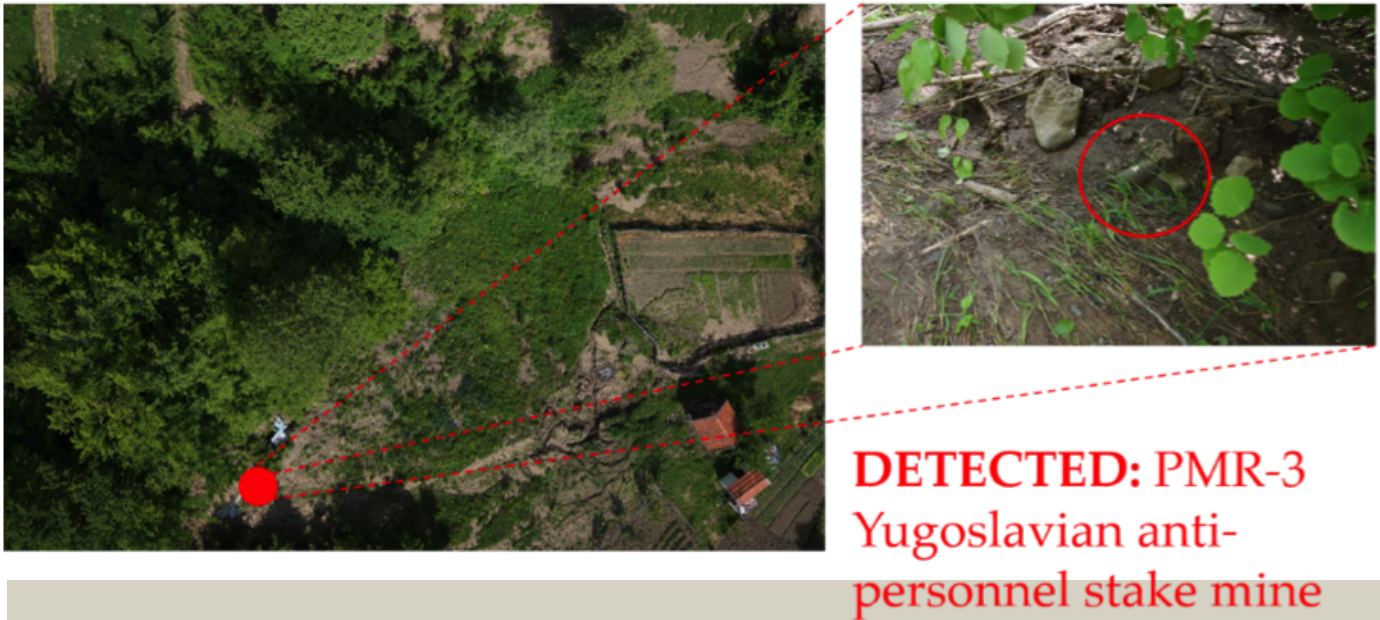
Figure 4 Identification of mines displaced by flooding and landslides.
© ICARUS.

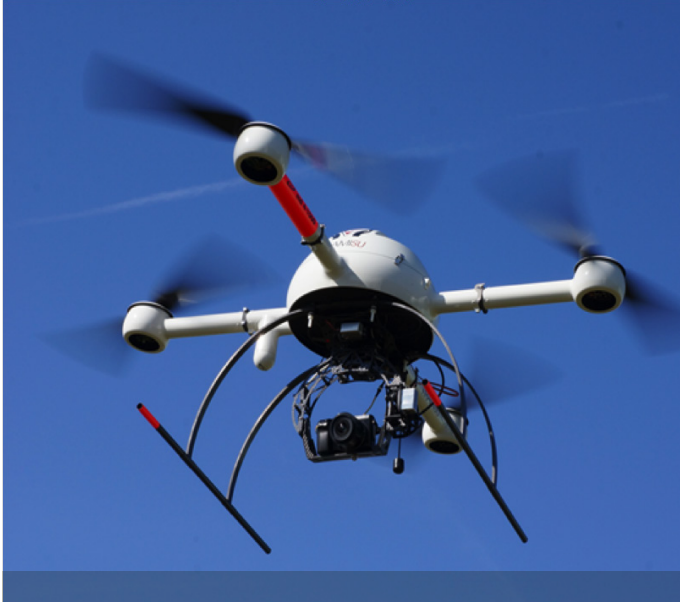
Figure 5 The ICARUS multi-rotor UAV with camera and gimbal in flight. © ICARUS.

Between May and June 2014, the RMA team deployed MD4-1000 Multicopter Microdrones along with two types of sensors—a high-resolution digital camera and a near infrared (NiR) camera. The microdrone has a flight time of up to 88 minutes (depending on load and battery) and a flight radius of up to 40 kilometres. The RMA team logged a total of 20 flights (both manual and autonomous) from 13 locations in urban and semi-urban areas. The flight times ranged from 25 to 30 minutes and captured 200 to 500 images at a resolution of 2-5 cm on each flight. The temperature ranged from 20°C to 25°C with a maximum wind speed of up to 7 metres per second where the flights were carried out. Flights were rescheduled when wind speeds reached more than 12 metres per second. The team did not map the entire risk area since the size of the suspected hazardous area before the disaster was 1 207 square kilometres.
